# Mech

*The Naval Safety Center's Aviation Maintenance Magazine*

## Vol. 42, No. 2 Spring 2003

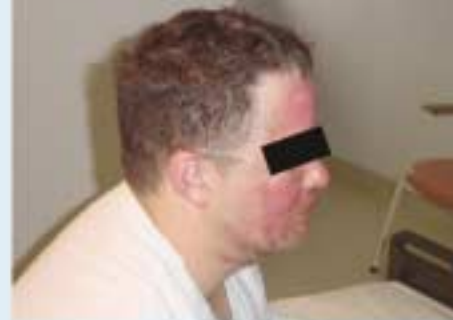
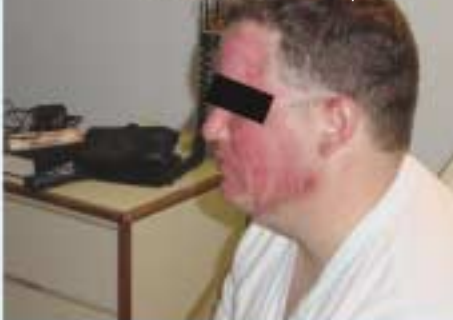
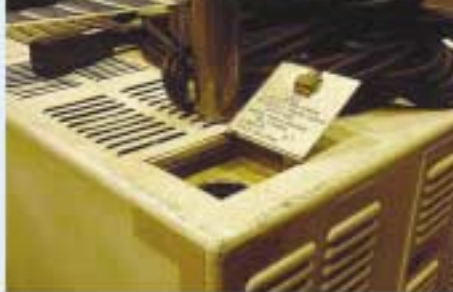
Burned from forehead to chin

and from cheek to cheek,

a Sailor learns fuel and flame don't mix.

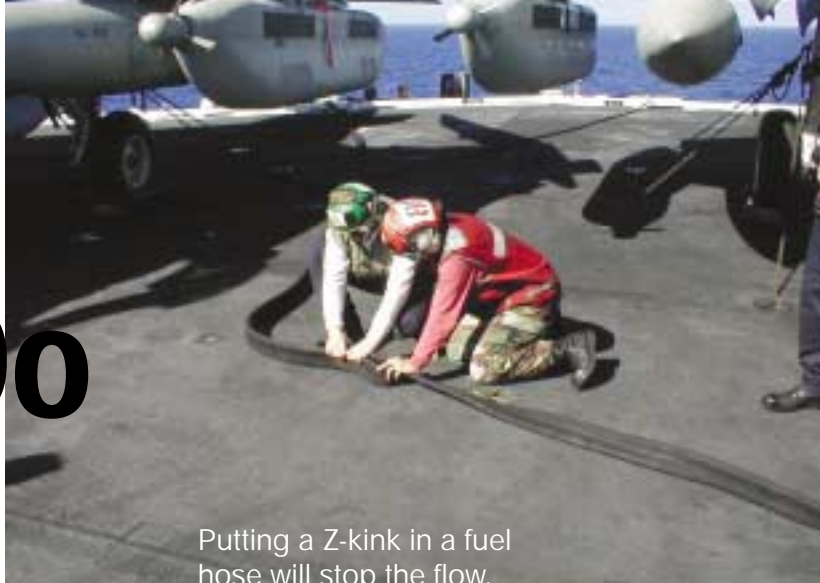
Putting a Z-kink in a fuel hose will stop the flow.

This kink caused the hose to rupture and to separate completely from the fitting. Fuel sprayed into the air and all over the deck, soaking the airframe troubleshooter, plane captain, and me. Realizing immediately the wet soggy feeling was not sweat and the ever-expanding pool beneath me was not water, I scrambled to the port side of the aircraft. I signaled frantically for an emergency shutdown and for the aircrew to exit the aircraft.

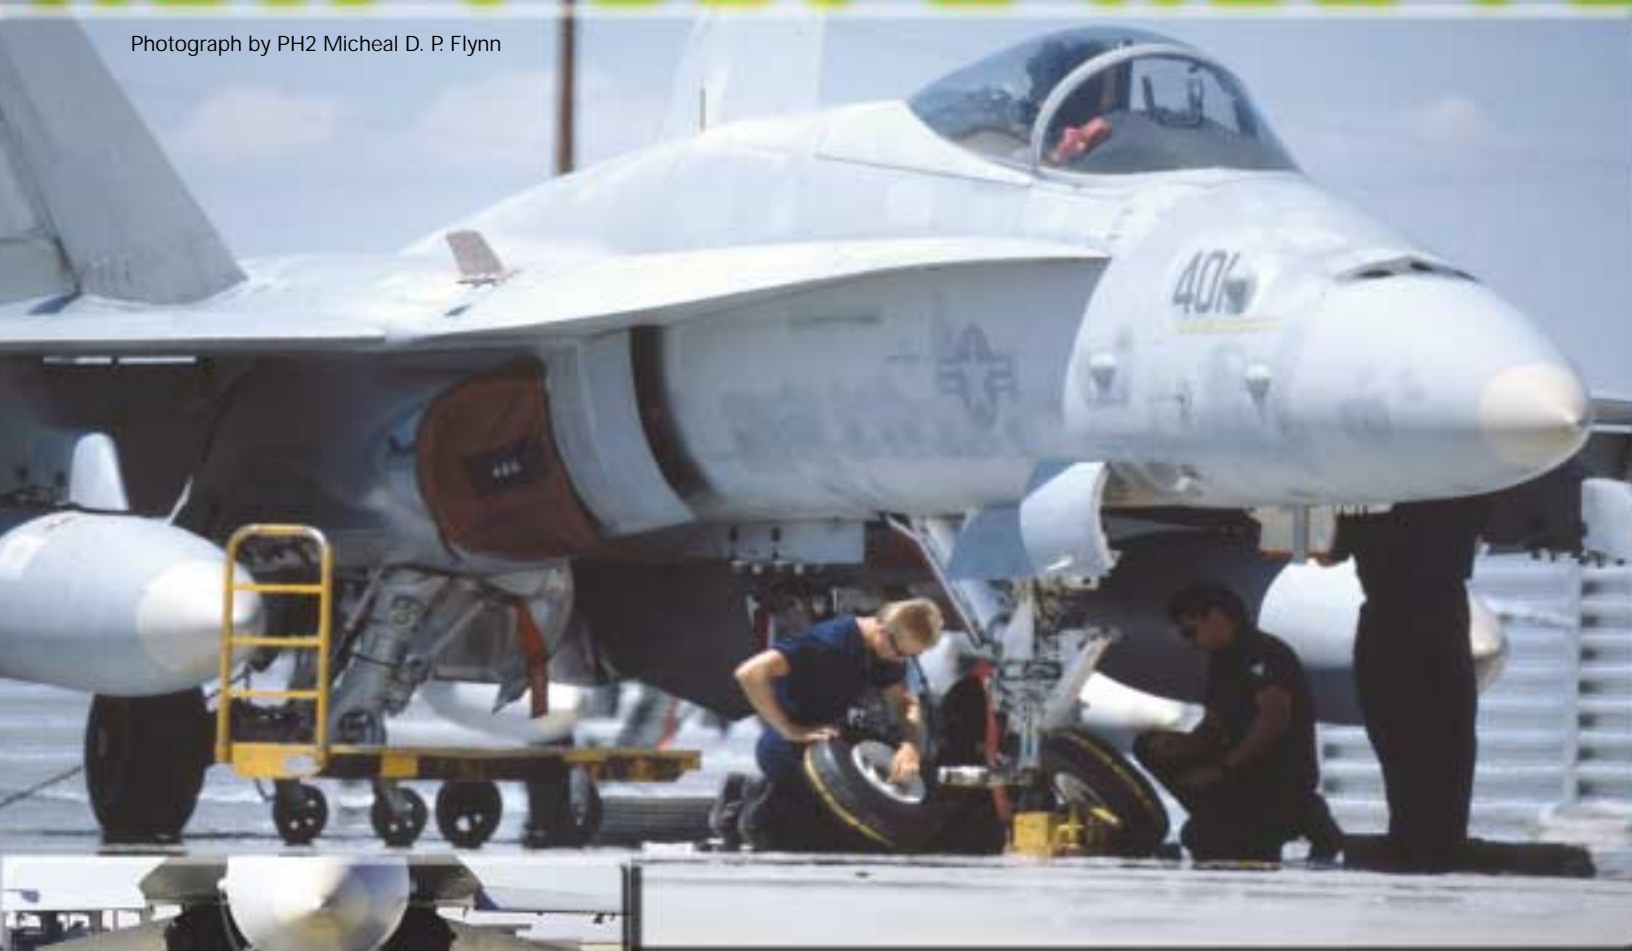
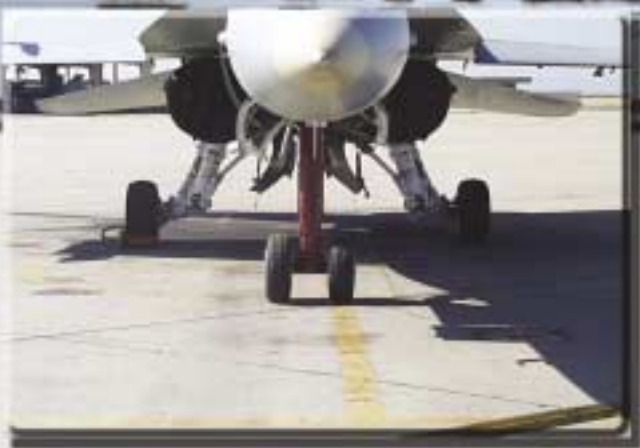
A "red leg" takes the place of a strut that isn't available.

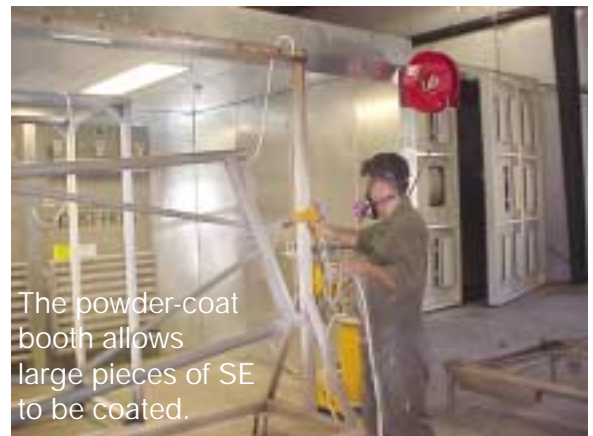
The powder-coat booth allows large pieces of SE to be coated.

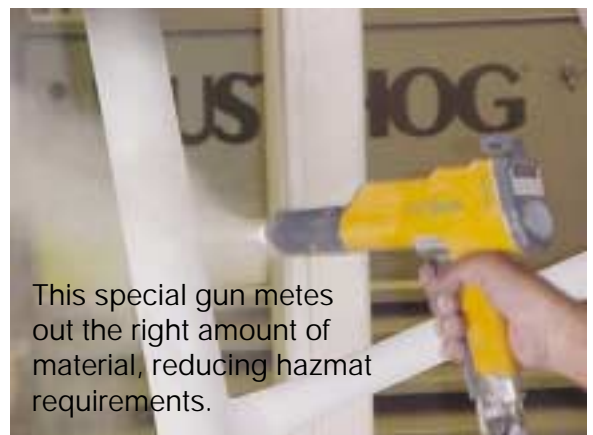
This special gun meters out the right amount of material, reducing hazmat requirements.

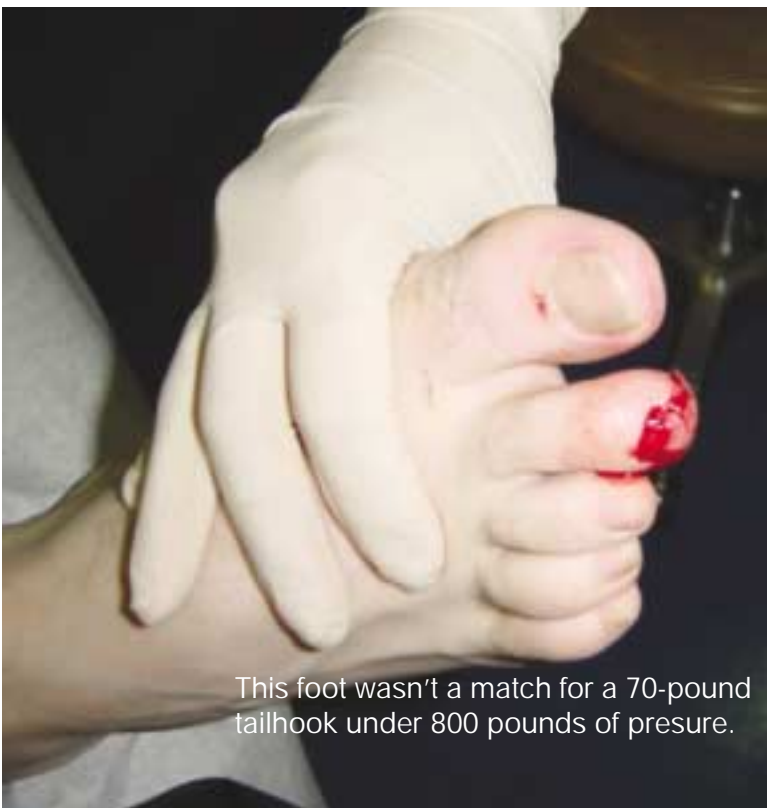
This foot wasn’t a match for a 70-pound tailhook under 800 pounds of pressure.

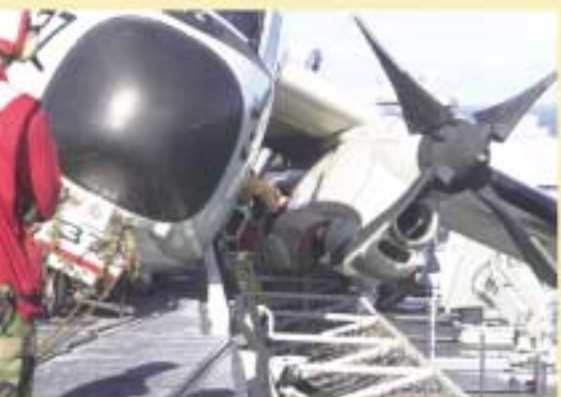
A greyhound drifted left and stopped in the port catwalk.

The aircraft dropped down to the engine.

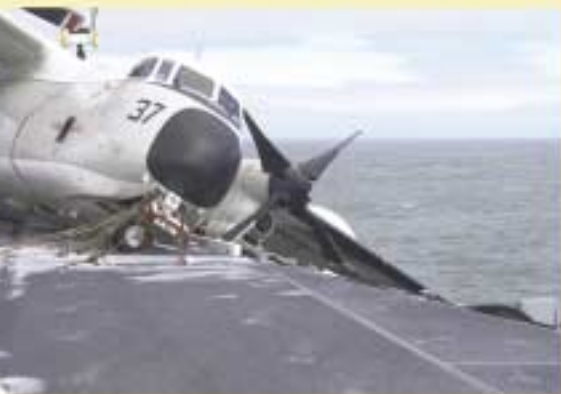
The flight-deck crew tied down the C-2 with as many chains as they could fit.

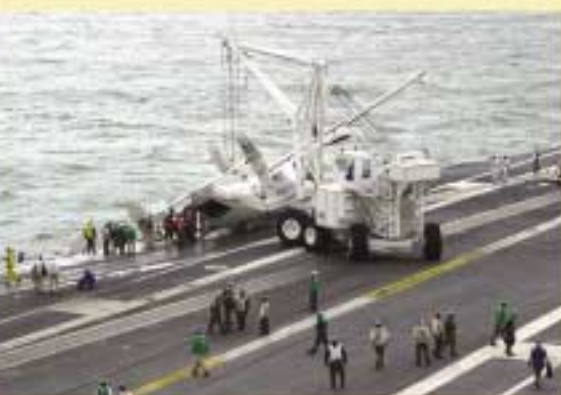
They removed the passengers and brought out "Tilley."

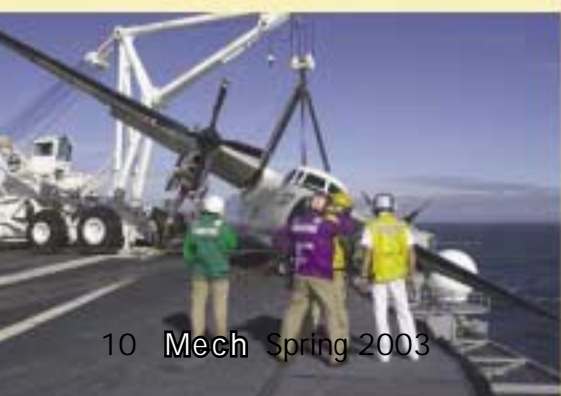
The aircraft was lifted out of the catwalk and secured.

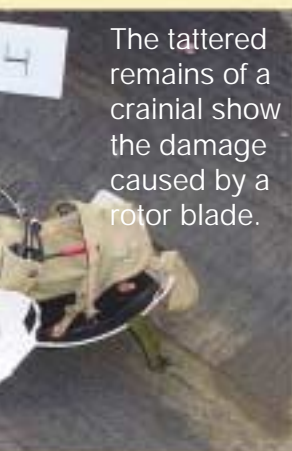
The tattered remains of a cranial show the damage caused by a rotor blade.

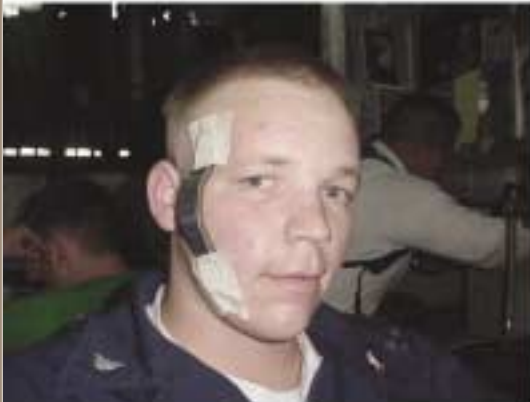
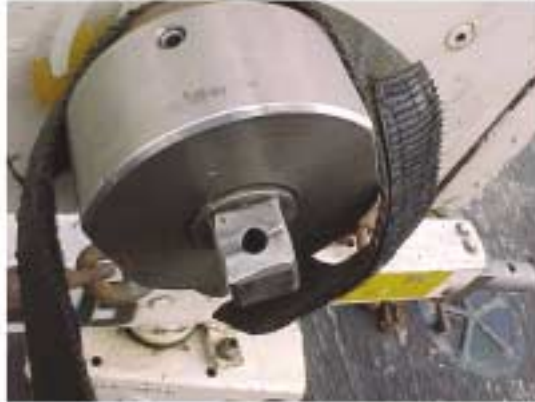
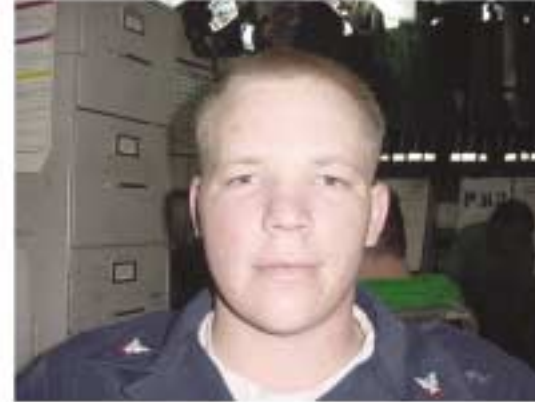
A hit to the face...

from a worn winch assembly...

will make your face swell.

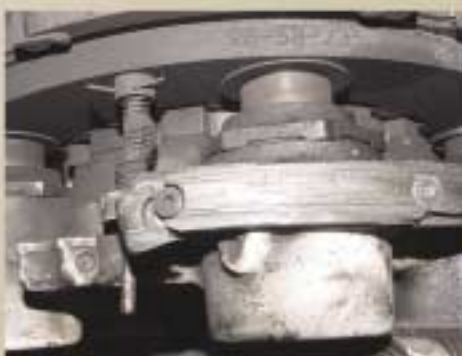
The wrong bearing caused this brake damage...

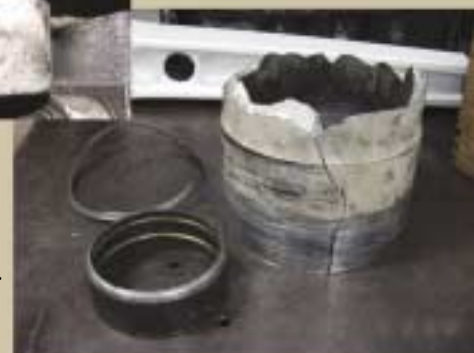
and this axle damage.

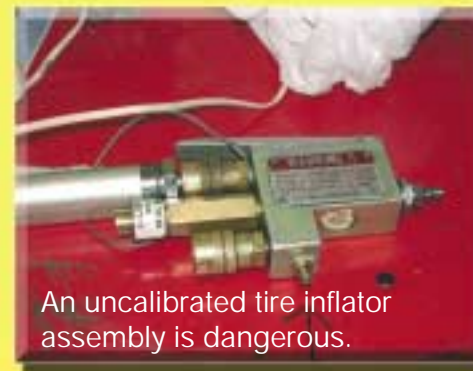
An uncalibrated tire inflator assembly is dangerous.

Periodic maintenance requirements for the tire inflator kit, P/N M85352/1 and dual chuck stem gauge, P/N M85352/4, are located in NavAir 17-600-174-6-2, and the pre-operational checklist is NavAir 17-600-174-6-1. These MRCs should be accessible and used by all qualified tire-and-wheel technicians.
